| DRAWN | JAM | 3/20/20 | TITLE:<br><br><b>1999 REPAIR KIT</b><br>SEE NOTE ABOVE | | |
| THE INFORMATION CONTAINED IN THIS DRAWING IS THE SOLE PROPERTY OF TEXAS INDUSTRIAL REMCOR, INC. ANY REPRODUCTION IN PART OR AS A WHOLE WITHOUT THE WRITTEN PERMISSION OF TEXAS INDUSTRIAL REMCOR, INC. IS PROHIBITED. | | | <b>A</b> | <b>KT 2045</b> | <b>A</b> |

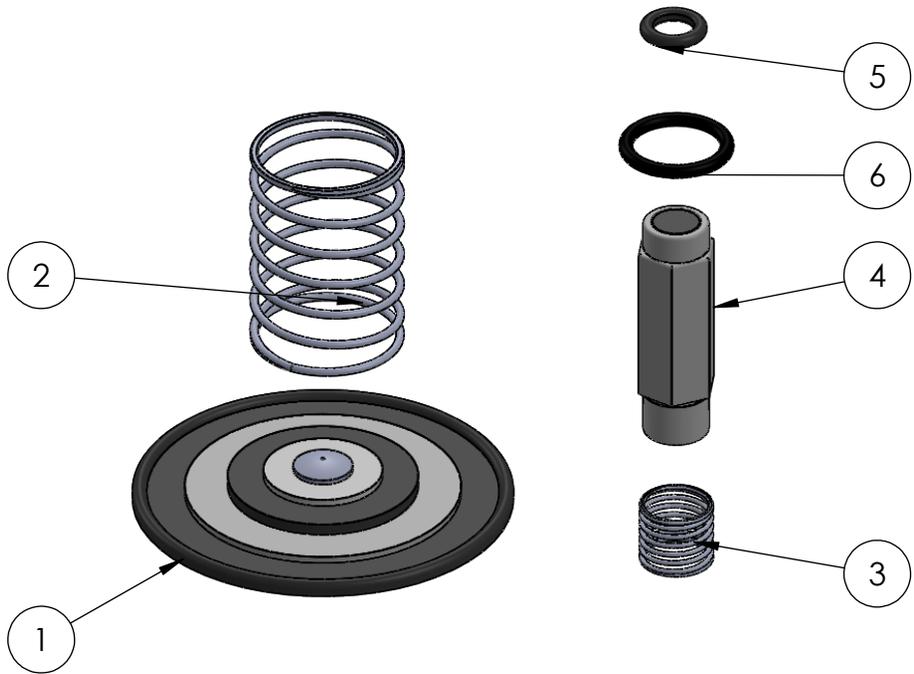
| ITEM NO. | PART NUMBER | DESCRIPTION | QTY. |
|---|---|---|---|
| 1 | SL 1974 | DIAPHRAM SEAL ASM VITON | 1 |
| 2 | SP 1975 | DIAPHRAM SPRING | 1 |
| 3 | SP 1979 | PLUNGER SPRING | 1 |
| 4 | PLGR.6978 | 1-1/4"L PLUNGER WITH VITON SEAT | 1 |
| 5 | OR 1976 | O-RING VITON (010) | 1 |
| 6 | OR 1977 | O-RING VITON (014) | 1 |

1999A "A" ON LABEL DENOTES CURRENT COIL MFG USING A 1" L PLUNGER
